# Fire Endurance of Open-Web Steel-Joist Floors With Concrete Slabs and Gypsum Ceilings

James V. Ryan and Edward W. Bender

Building Materials and Structures Report 141

Issued August 23, 1954

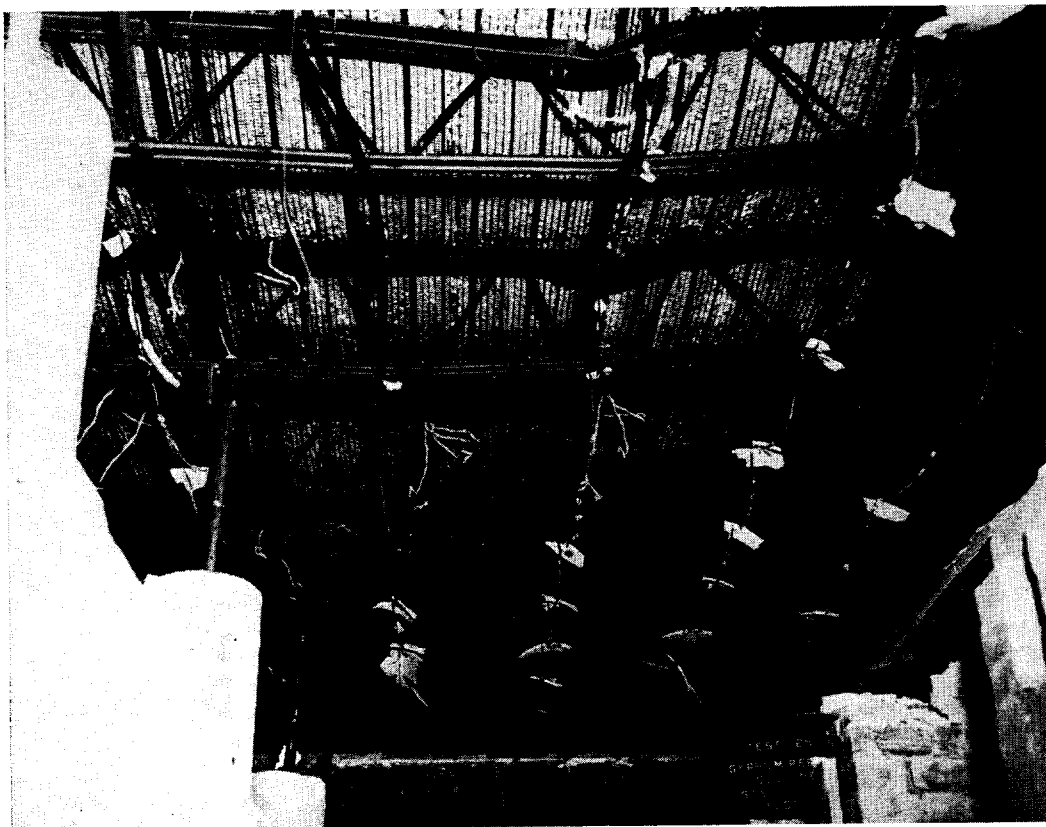
**Test 295.** Ceiling of 1 in. of plaster on  $\frac{3}{8}$ -in. lath, same slab and joists as in test 287. At 2 min, white-coat plaster peeling from over half ceiling; 18 min, spot about 6-in.-diameter sagging; 27 min, half of above spot fell, another sagging 1 in.; 34 min, cracks along lines of lath joints over most of ceiling; 48 min, slight sag along crack; 1 hr 3 min, several cracks  $\frac{1}{8}$  in. wide, others less; 1 hr 26 min, offset of  $\frac{1}{4}$  in. along crack; 1 hr 36 min, sag of 2 in. at lath corner; 1 hr 36½ min, about 5 ft<sup>2</sup> of ceiling fell; 1 hr 43 min, load removed, floor continued to deflect under deadweight, about one third of ceiling down; 1 hr 49 min, nearly all ceiling down, joists buckling; 1 hr 53 min, gas off.

FIGURE 6. Condition of joists after test 295 of specimen with unreinforced ceiling showing buckled joists.

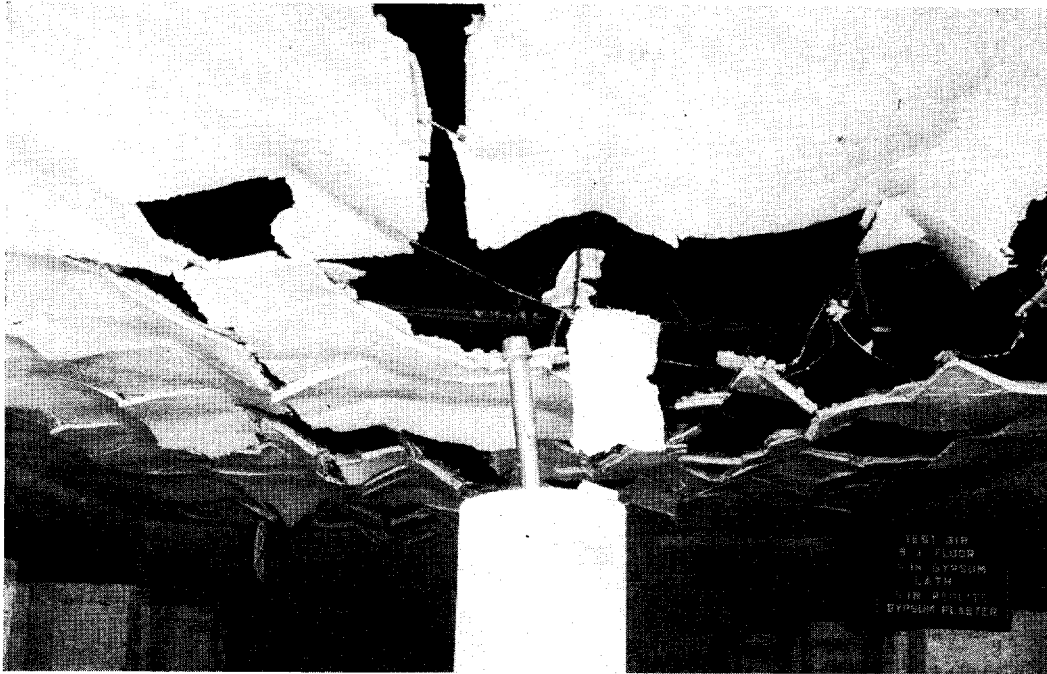
**Test 318.** Diagonal wires 11.3 in. apart, plaster ½ in. on ¾-in. lath. At 8 min, first crack; 15 min, smoke from single crack; 19 min, cracks partially outlined laths; 24 min, slight sagging along two cracks; 31 min, offset of ¼ in., some peeling of white coat; 35 min, entire ceiling surface had wavy appearance; 50 min, wavy appearance lessening except for 3-in. sag along two cracks; 1 hr 15 min, corner of lath and plaster sagging 1¼ in.; 1 hr 35 min, maximum crack width 1½ in., local sag as much as 4 in.; 2 hr 6 min, many cracks ½ to 2 in. wide, corners of lath and plaster hanging down 3 to 8 in., leaving openings about 6 and 10 in. square; 2 hr 27 min, about 2½ ft² of ceiling fell; 2 hr 47 min, load off; 2 hr 53 min, gas off.

Less than one-quarter of the ceiling fell during the test and subsequent cooling. Most of the joists were bent, a few buckled slightly, and the floor slab showed no appreciable cracking.

FIGURE 7. *Condition of ceiling after test 318 of specimen with diagonal wire reinforcing.*  
One or two smoothly bent joists may be seen through the opening in the ceiling.

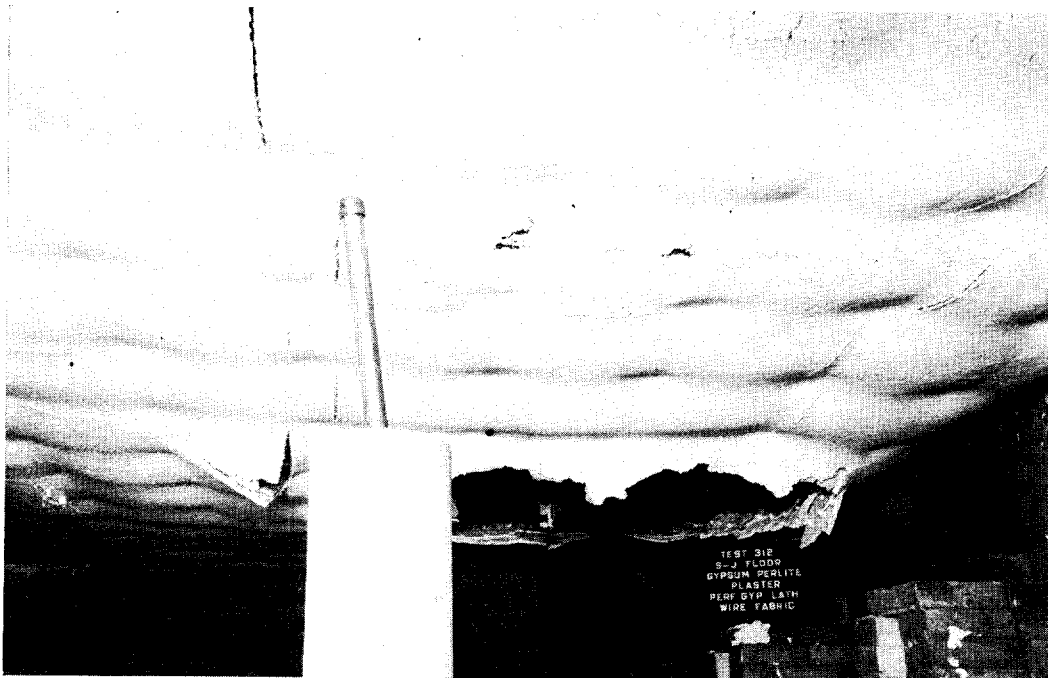
*Test 312.* Plaster  $\frac{1}{2}$  in. on  $\frac{3}{8}$ -in. lath. At 13 min, first crack; 27 min, short cracks outlined laths over part of ceiling; 1 hr, maximum crack width  $\frac{1}{8}$  in., length 3 ft, 1 hr 45 min, several parallel transverse bulges or sags of small depth, probably between lines of support for wire mesh; 2 hr 43 min, small edge cracks in floor slab, little change in ceiling; 3 hr, maximum crack width  $\frac{1}{8}$  in., length 6 ft; 4 hr, ceiling had developed 1 to 2 in. general sag; 5 hr, general sag of ceiling had developed into curve of 9-in. depth at center; 5 hr 20 min, local sag of  $\frac{1}{2}$  in. over area 3 ft in diameter; 6 hr 15 min, ceiling fell from 4-ft<sup>2</sup> area near center; 6 hr 27 min, load off; 6 hr 34 min, gas off, more ceiling down.

FIGURE 8. *Condition of ceiling in test 312, having hexagonal-mesh wire fabric, after 6½-hour exposure.*
